SERVICE BULLETIN

from: TRIO-KENWOOD COMMUNICATIONS, INC.

SUBJECT: SERVICE NOTES ON TS-820

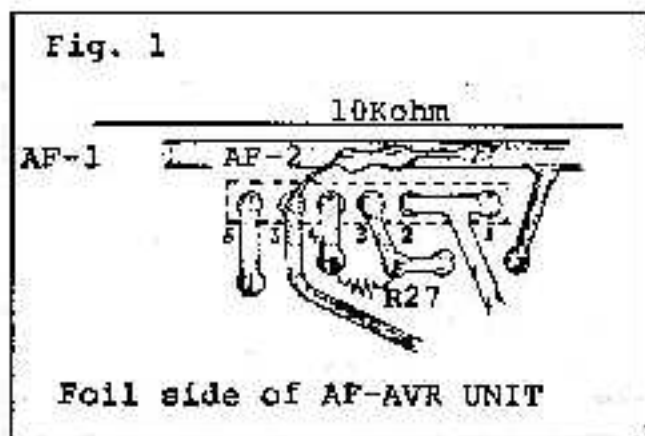
We have had a few reports of the TS-820 RIT tuning being "rubbery". The following information will solve this.

1. Remove resistor R27 (1Kohm) on AF-AVR UNIT (X49-1080-00).
2. Install a 10Kohm resistor on foil side of AF-AVR UNIT --- see Figure 1.
3. Install a 1Kohm resistor on RIT control --- see Figure 2.
4. Install a capacitor (3.3 μ F-10 μ F) between RIT control and ground --- see Figure 2.
5. Adjust VR-2 on AF-AVR UNIT (X49-1080-00) for the same frequency as the center position of the RIT control.
